## PSL-3604 – Hardware Upgrade

Boards rev. 1

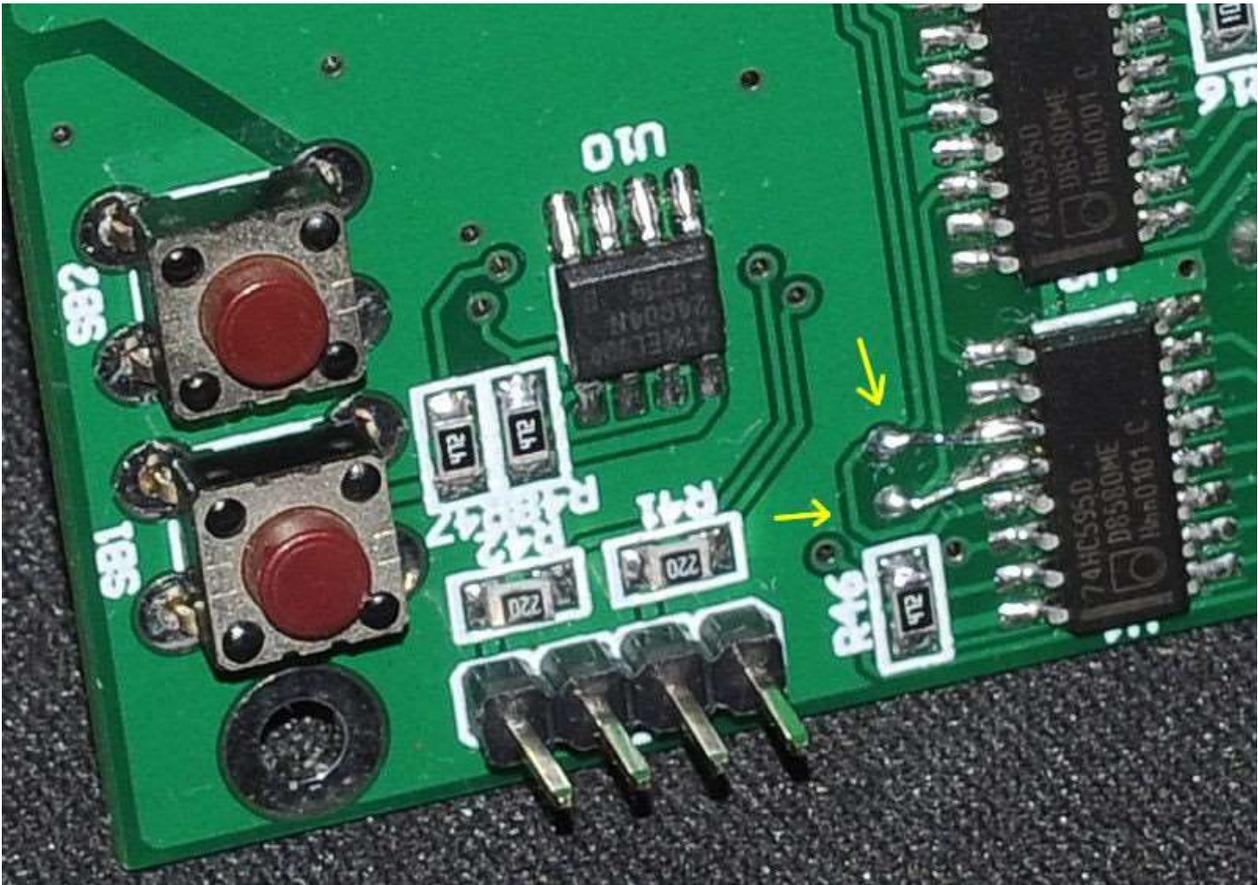
Fig. 1.

1. There is an error in the schematic of the front panel – pins 11 and 12 of register U4 are mixed up. It is corrected by jumpers, the necessary vias are located next to it (Fig. 1). Pin tracks 11 and 12 are trimmed before jumpers are installed.

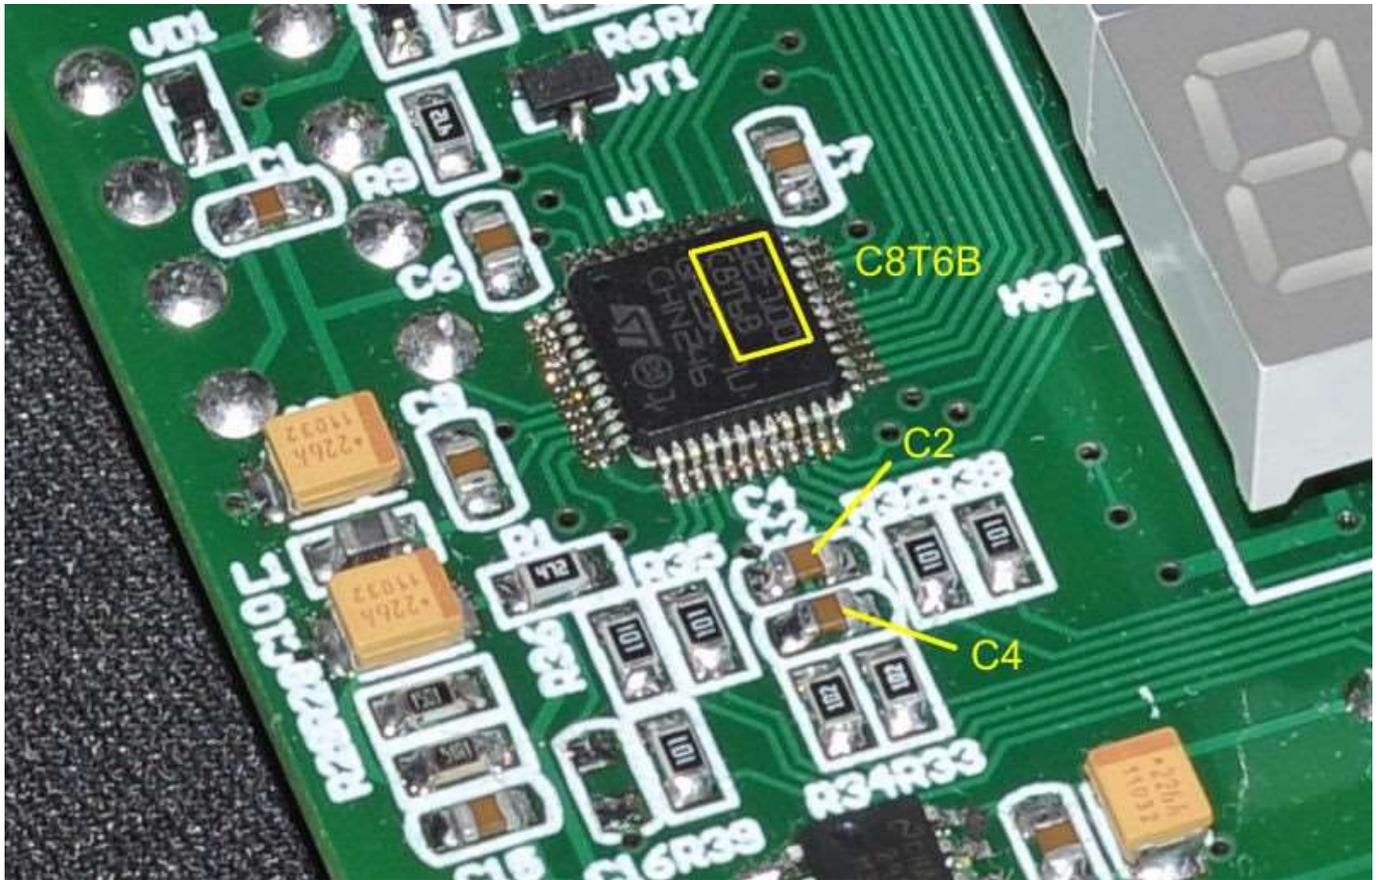
Fig. 2.

2. The processor has been replaced with STM32F100C8T6BB (Fig. 2).
3. There was an ADC error of several units. It is corrected by replacing the C2 and C4 capacities at the input of the ADC with 220 pF (Fig. 2).  
Explanation here: read [STM32 ISSUE](#)

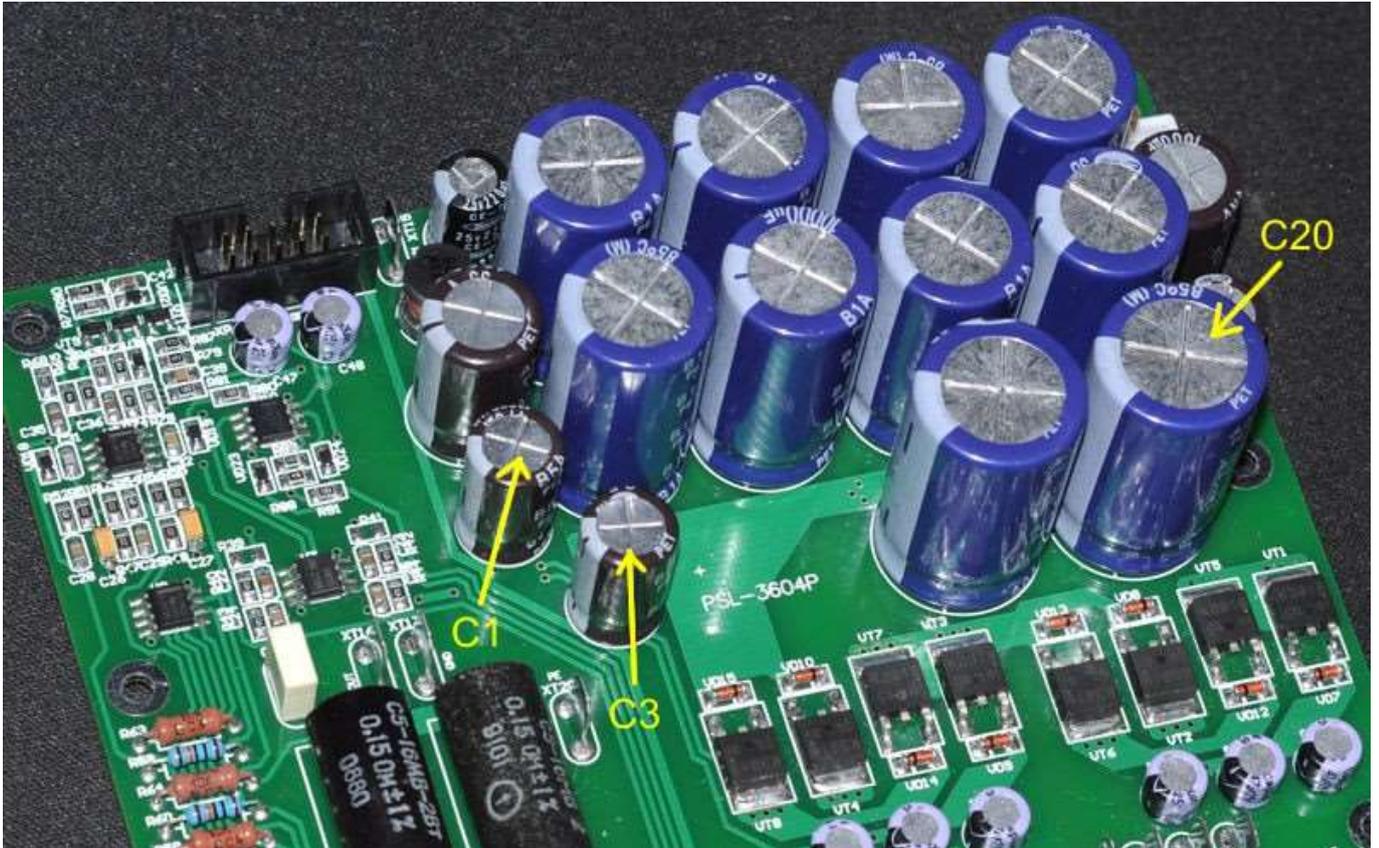
Fig. 3.

- The voltage across the C20 capacitor is about 48V, which is close to the maximum (50V). Replace the C20 capacitor with 2200  $\mu\text{F}$  x 63 V (Fig. 3). Such a replacement is only required if the transformer used provides such a high voltage. For lower voltage versions of the PSU, replacement is not required.
- The voltage at the input of the regulator is -5 V too high (about 20 V). Capacitors C1 and C3 need to be replaced with 47  $\mu\text{F}$  x 100 V (Fig. 3). In this case, the voltage is reduced to about 13 V, which is normal.

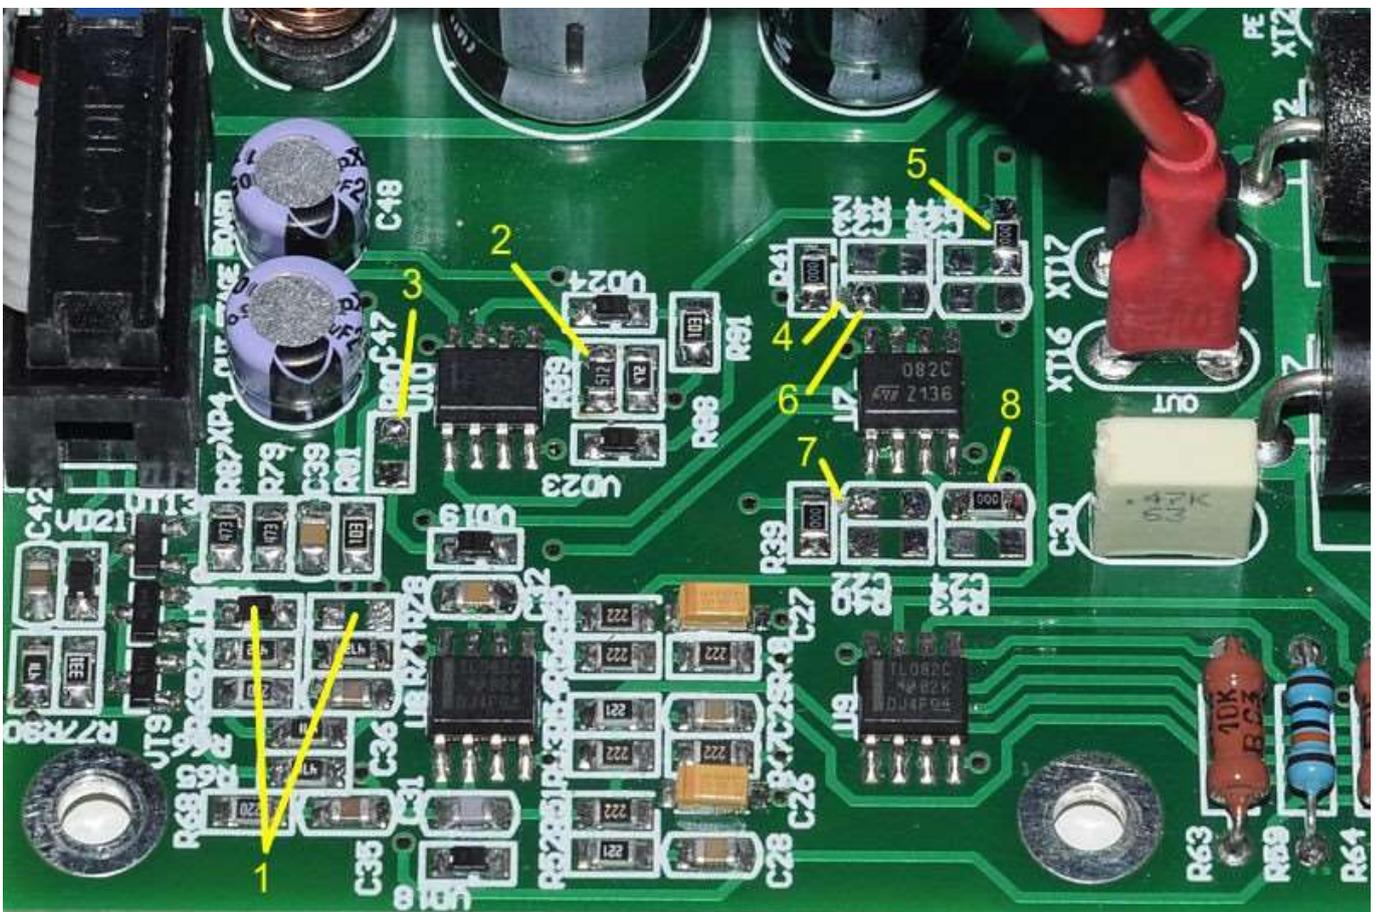
Fig. 4.

6. Remove components VD20, R78 (number 1 in Figure 4). It is enough to remove one of the components, I did not remove the diode. In principle, they are not very disturbing, but there is not much benefit either. Components were introduced to reduce the downward surge that was observed when the voltage was abruptly reduced at some load capacitances. But the emission is very small (about 100 mV), there is no point in fighting.

7. Replace the R89 on the power board with 5.1 k $\Omega$  to correctly detect the status of the incoming output current (number 2 in Figure 4). Here there were disagreements with the simulator, he is too optimistic about the maximum range of voltage at the output of the op amp.

8. To detect the Unregulated status, the input of the U10 comparator (LM358) must be disconnected from the output of the current error amplifier by removing R80 (number 3 in Fig. 4). A hole is drilled on the R80 pad, through which the jumper connecting pin 2 U10 to the GNDA polygon is soldered. Modification is not mandatory, with it the PSU will signal a situation when it is unable to maintain the output voltage (for example, due to a network drawdown).

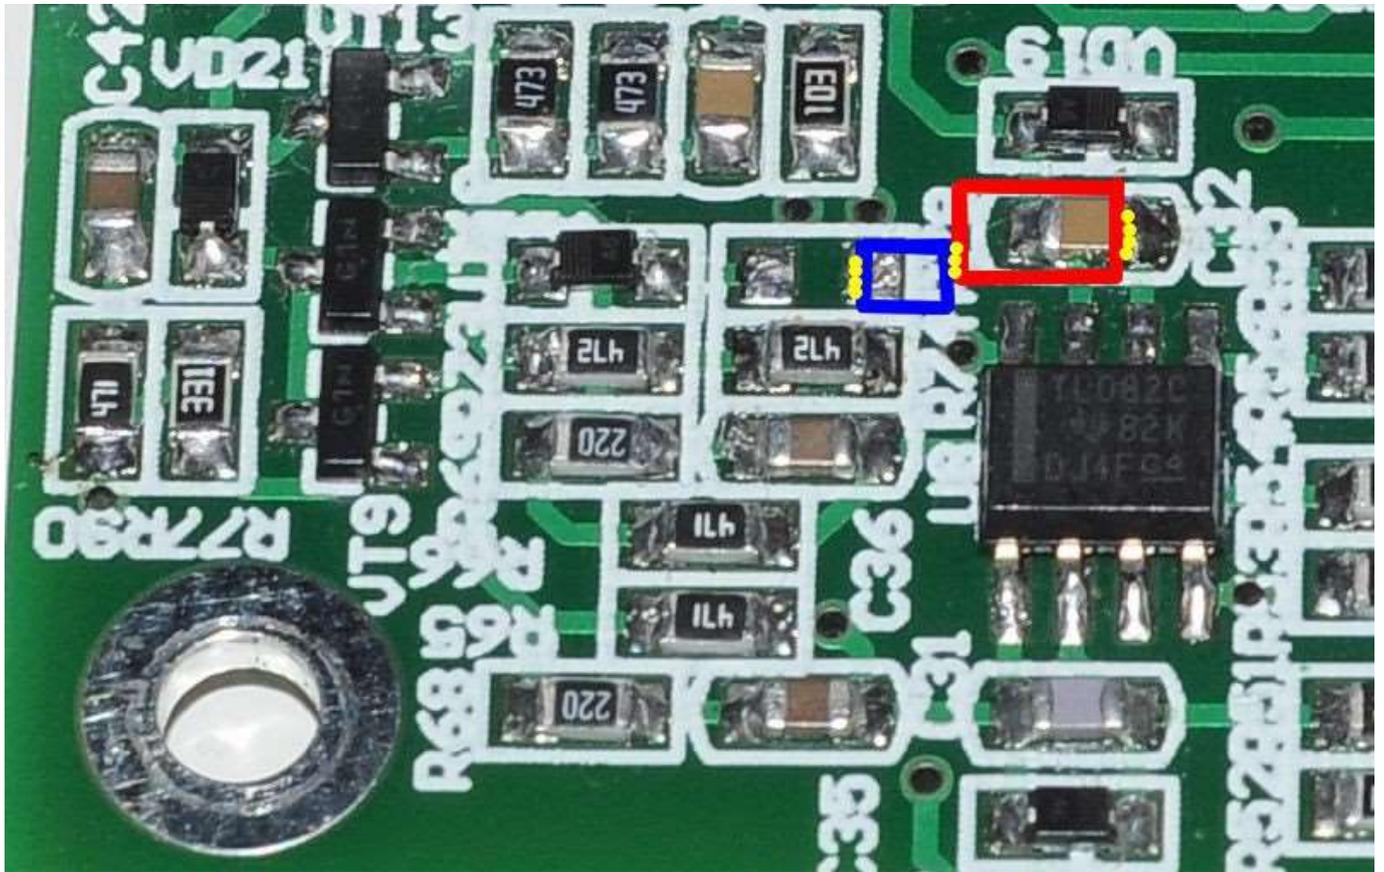
Fig. 6.

11. When there is a transition between the two levels of current stabilization, a surge is observed. To eliminate it, you need to add a chain of R98 10 k $\Omega$  and C51 1 nF. First, an R98 resistor of size 1206 (shown in red in Fig. 6) is mounted on the board above the C32, C51 of size 0805 is soldered to it (shown in blue in Fig. 6), which is soldered to the R78 pad with the second pin.

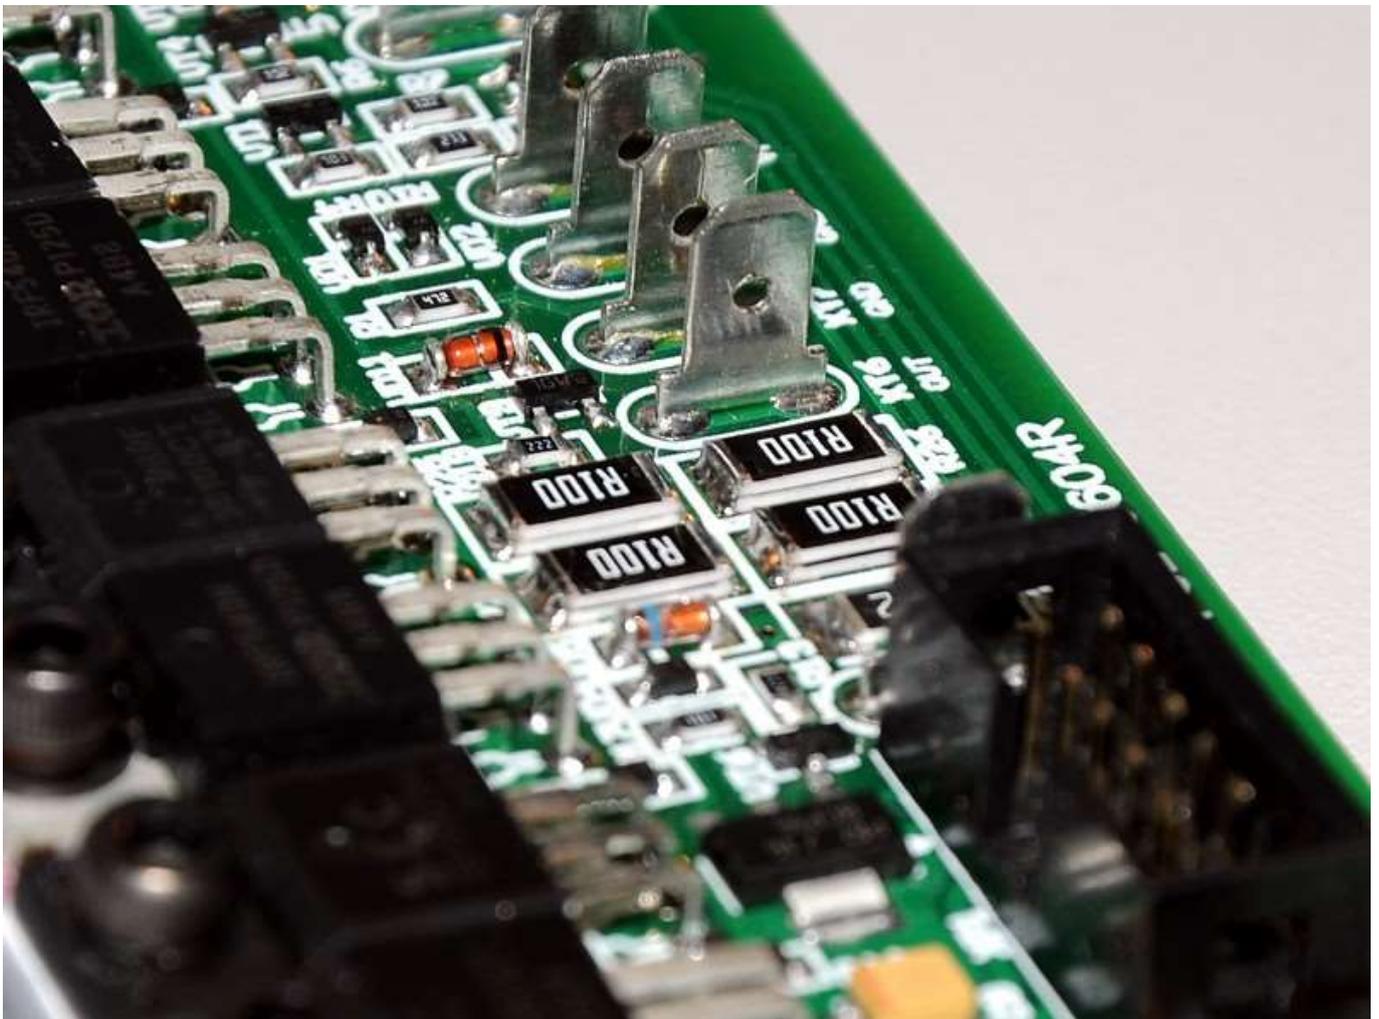
Fig. 9.

14. In parallel with the resistors R25 – R28 on the output stage board, I installed another resistor of the same kind in parallel (Fig. 9). As a result, the scattering power was reduced to an acceptable value.

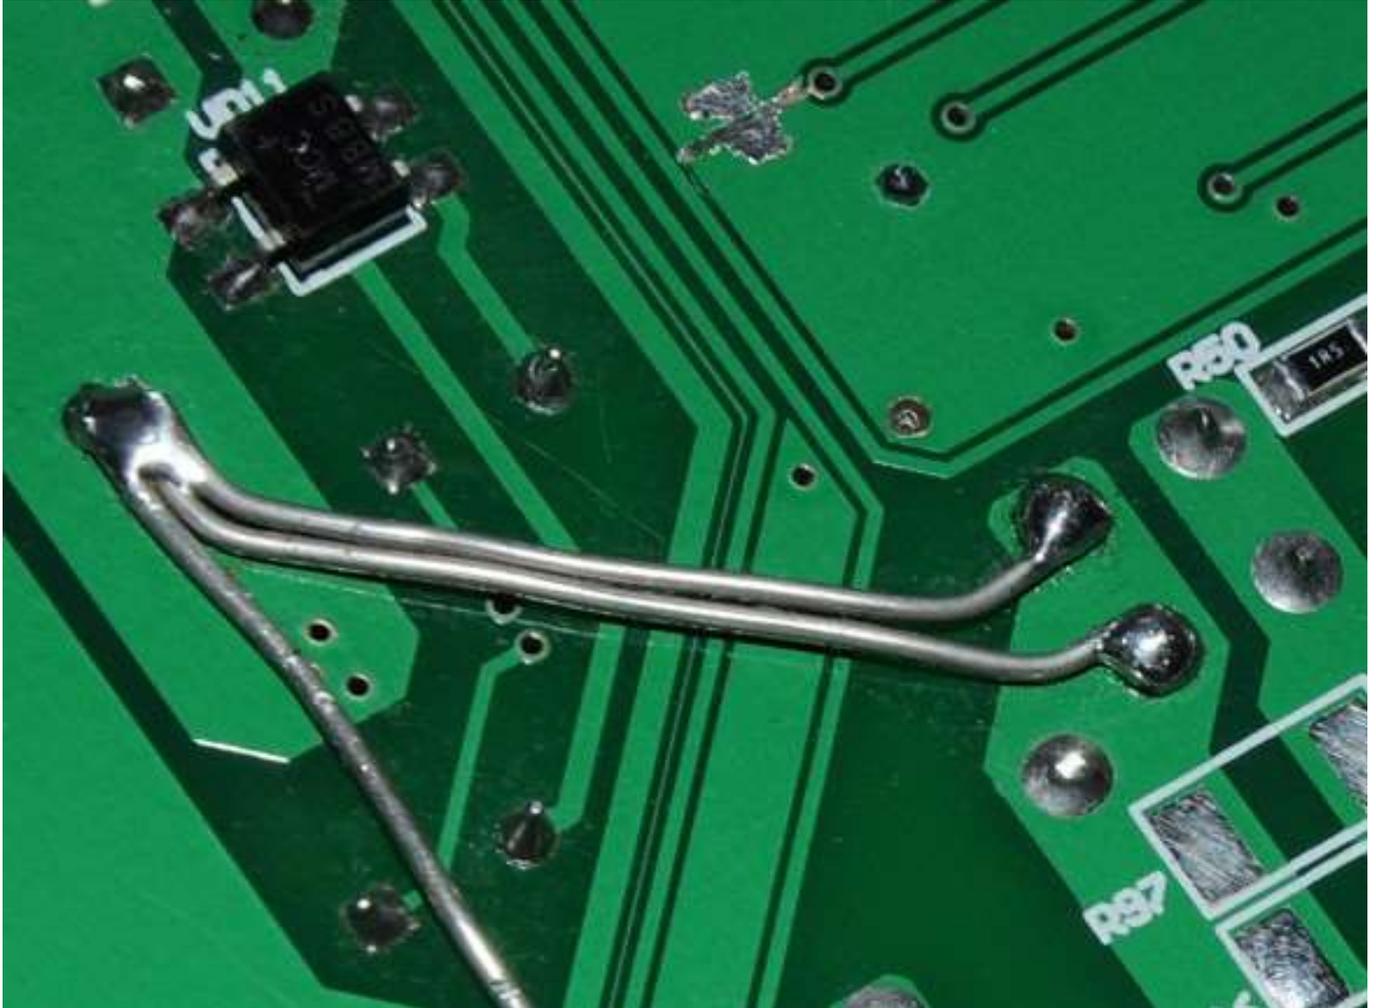
Fig. 10.

15. **Modification is not necessary** - to reduce the interference voltage on the COM signal relative to GND, connect the XT17 terminal (GND) on the main board to the power ground polygon (minus the C18 capacitor) (Fig. 10).

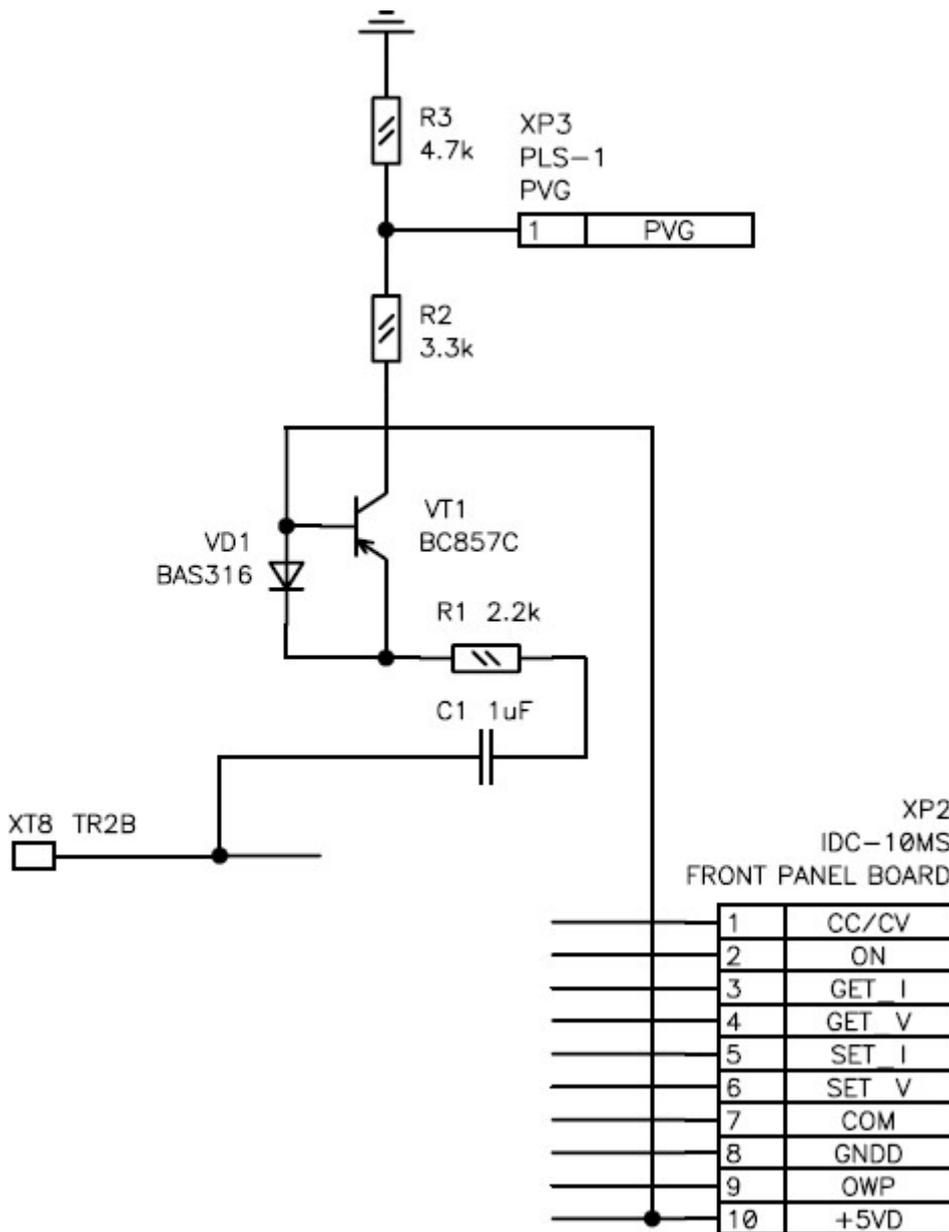
Fig. 11.

16. **Modification is not necessary** - when the power is turned off, all sorts of unnecessary values flash on the display, the sound emitter beeps. To fix the problem, you need to add a power detector circuit (see Figure 11). The circuit can be assembled by any method of mounting on the main board (Fig. 12). The output of this circuit is wound onto the pin, then connected to the pin on the front panel board with a wire (Fig. 14). It is pressed into a hole with a diameter of 0.7 mm drilled at the point marked in Fig. 13. The pin is connected by a jumper to pin 33 (PA12) of the controller (Fig. 15).
